Corrosion of Steel Pilings in Soils

Melvin Romanoff

National Bureau of Standards Monograph 58

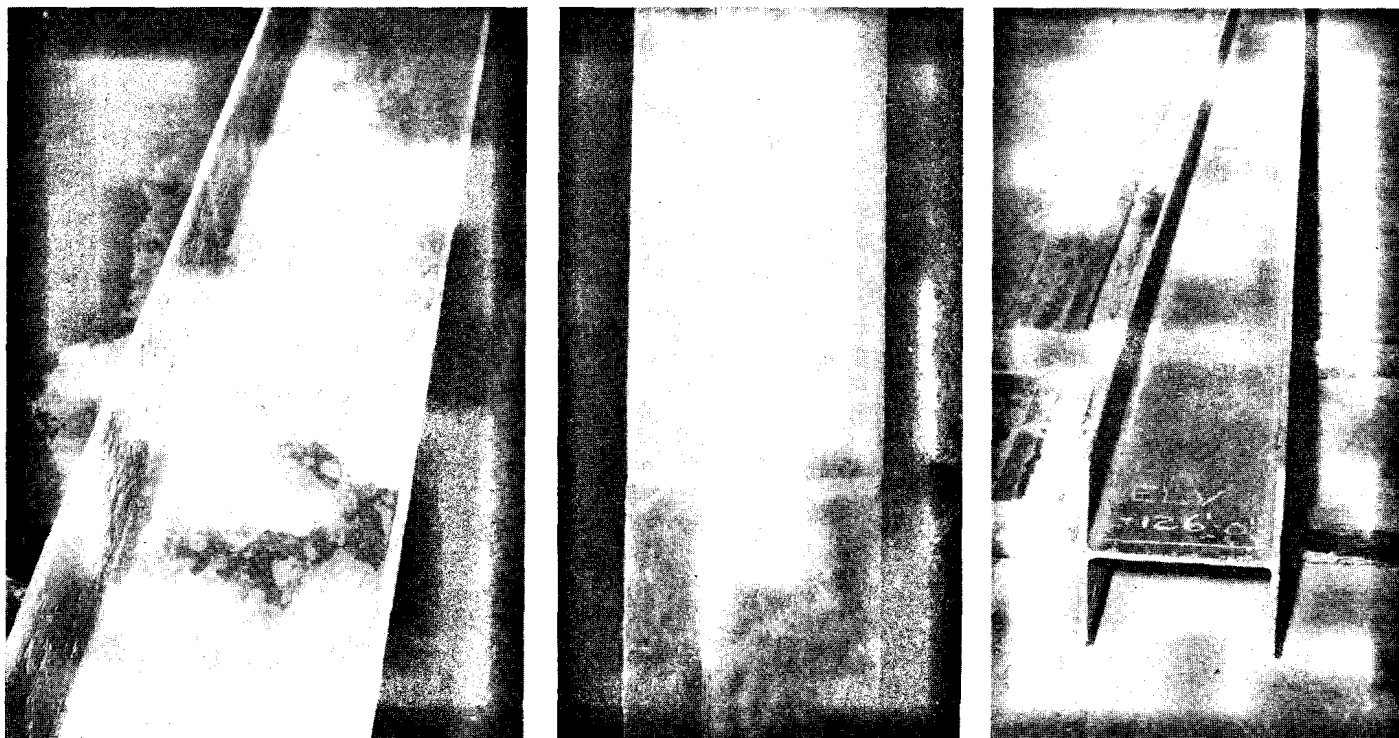
The pattern and amount of corrosion on the two piles were about the same. Corrosion was confined to two areas. One area extended from the top of the piles, which was above ground level, and extended through the zone exposed to the cinder and slag fill in the water table zone. The other corroded area occurred between elevations -115 to -118 ft where the piles passed through a sand and gravel bed.

+8 to +6: This is the zone showing the maximum corrosion on both piles. The water line was at +7 ft for pile I-S, and at +6.4 ft for pile II-S. The mill scale was practically entirely removed; uniform corrosion and many pits were present. Most of the pitting occurred within the 1-ft area above and below the water line. The two maximum pit depths measured on pile I-S were 112 and 90 mils, a few pits were found between 60 and 75 mils, and other pits less than 60 mils in depth. On pile II-S, there were 10 pits between 55 and 72 mils in depth and other pits less than 50 mils in depth. The flange surfaces were more severely attacked than the web surfaces.

-115 to -118: At this depth the piles passed through a sand and gravel stratum. The steel surfaces were uniformly corroded and contained many localized pits which generally ranged in depth up to 50 mils; 12 pits measured between 50 and 65 mils and 2 pits had depths of 80 and 95 mils. The average reduction in flange thickness measured 9 and 4 percent, respectively, for pile I-S and for pile II-S.

Figure 1 shows the condition of pile II-S at three different levels.

FIGURE 1. Sections of the 139-ft H-piles pulled from Sparrows Point, Maryland, after exposure for 18 years.

Left, water table zone consisting of fill material; center, clay soil stratum at about elevation -30 ft; and right, coarse sand and gravel stratum underlain by clay between elevations -110 and -126 ft. The pile was cleaned by sandblasting. Note the excellent condition of the butt weld at the splice in the center photograph.

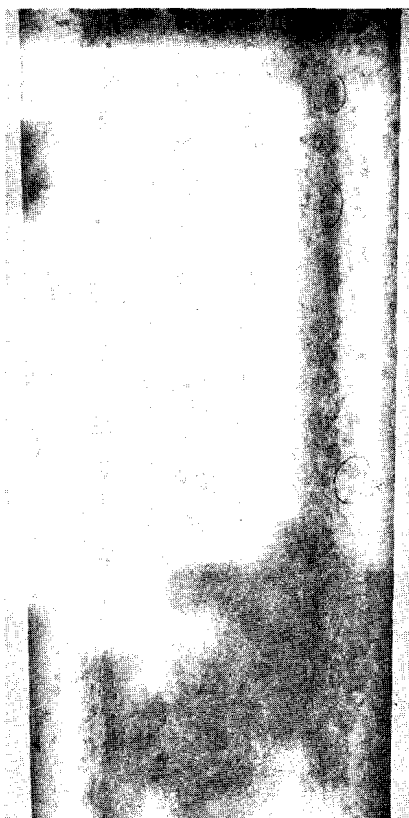
The entire length of the pile was driven below the water table. Corrosion was confined to a 2-ft section on the river side of the pile between elevation 59.8 to 61.8 ft. Pitting occurred in 11 places, each about 1 in.² in area, along the fingers of the pile. The maximum pit depth was 26 mils and others ranged up to 22 mils. Several pits having a maximum depth of 20 mils were found in a 3-in.² area in the center of the web. Ninety percent of the mill scale was intact in this moderately corroded zone. At least 95 percent of the original mill scale was found to be intact on the remaining areas of the pile, and no measurable pits or corrosion beyond the mill scale was observed. Based on the maximum pit depth, the total loss of pile thickness in the corroded zone could not exceed 5 percent of the original pile thickness.

FIGURE 2. Sandblasted 3-ft section from the 40-year-old piling extracted from an abutment wall in the Corps of Engineers Dam and Lock No. 8 on the Ouachita River near El Dorado, Arkansas.

The section was exposed about 18 ft below the ground line and it is the only portion of the pile which contained pits of measureable depth. The maximum pit was 26 mils in depth.

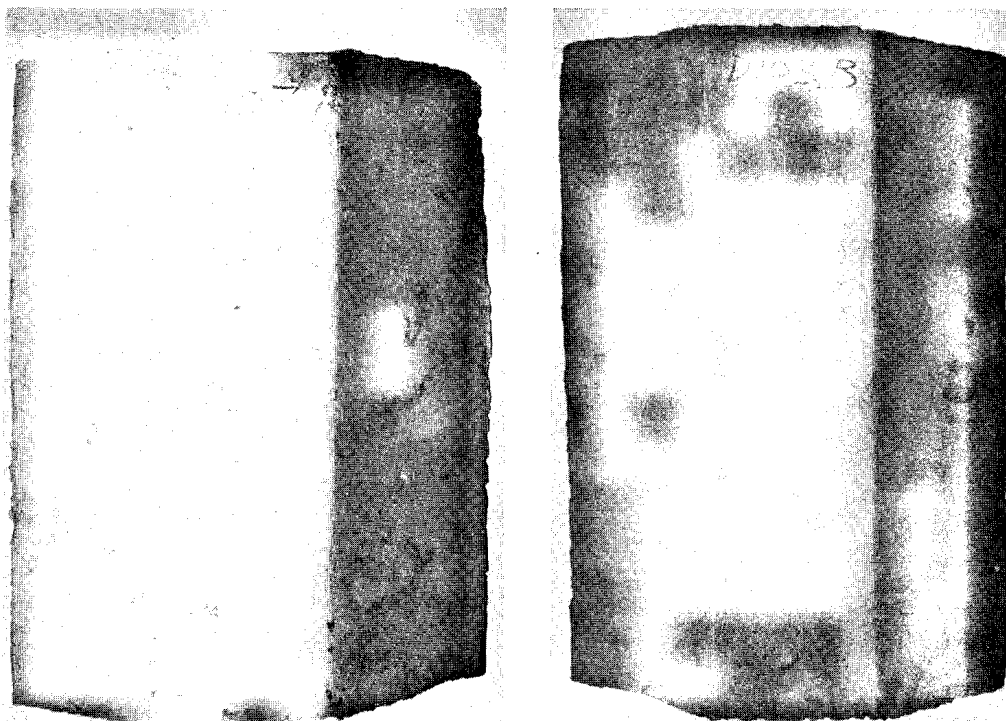
FIGURE 3. Sections (1.5 ft by 1 ft) cut from a piling which was pulled from the north upstream wingwall of the Grenada Dam Spillway at Grenada, Mississippi, after exposure for 12 years.

Sections were cleaned by sandblasting.
D103A, section of pile exposed to fill soil.
D103B, section of pile exposed to natural soil.

251.5 to 246.0 ft: Many scattered pits up to 50 mils in depth. Seven pits measured between 68 and 80 mils, and two pits 88 and 122 mils in depth. Pits were of similar depth on both sides of the pile, but much less numerous on the side facing the spillway. About 50 percent of the mill scale was intact on the spillway side and 10 percent on the other side. The reduction in cross section of the three most corroded areas measured between 6 to 8 percent of the original wall thickness.

244.0 to 237.5: About 75 percent of the mill scale was present over the surfaces in this zone. No measurable pits were found except two at elevation 241.0 ft which were 13 mils in depth. The average wall thickness of a 17 × 22 in. section removed from this zone was 0.37 in. after cleaning by sandblasting.

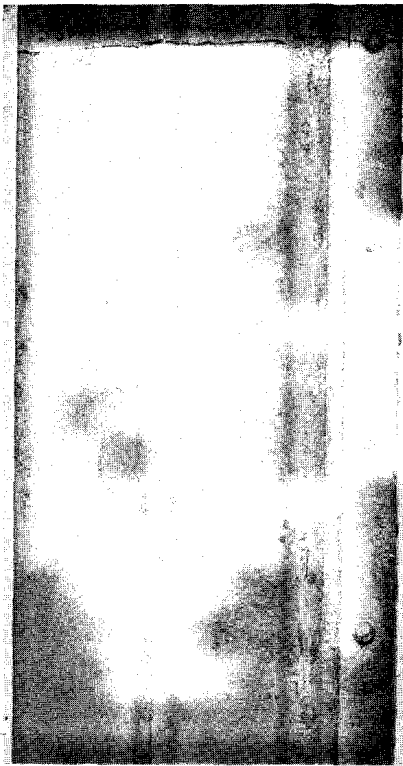
+2.5 to 0 ft: Section exposed to total or partial water immersion, or atmosphere. Uniform corrosion of surface. Measurements of the cross section in the top 6 in. of the piles (elevation +2.5 to +2.0) showed a minimum thickness of 0.06 in. in places. This represents a loss of 76 percent in the original pile thickness. The maximum thickness measured on uncorroded surfaces near the bottom of the piles was 0.26 in. Piles in the zone between +2.0 ft to the ground line showed a maximum reduction in thickness of 60 percent.

-3 to -17.5: In this zone the condition of the surface was similar to that described above, but was less severely corroded. Many isolated pits measured up to 30 mils in depth, and relatively few up to 60

FIGURE 4. A 3-ft section of steel sheet piling exposed below the soil line in a cofferdam structure in the Lumber River near Boardman, North Carolina.

Exposure, 37 years.

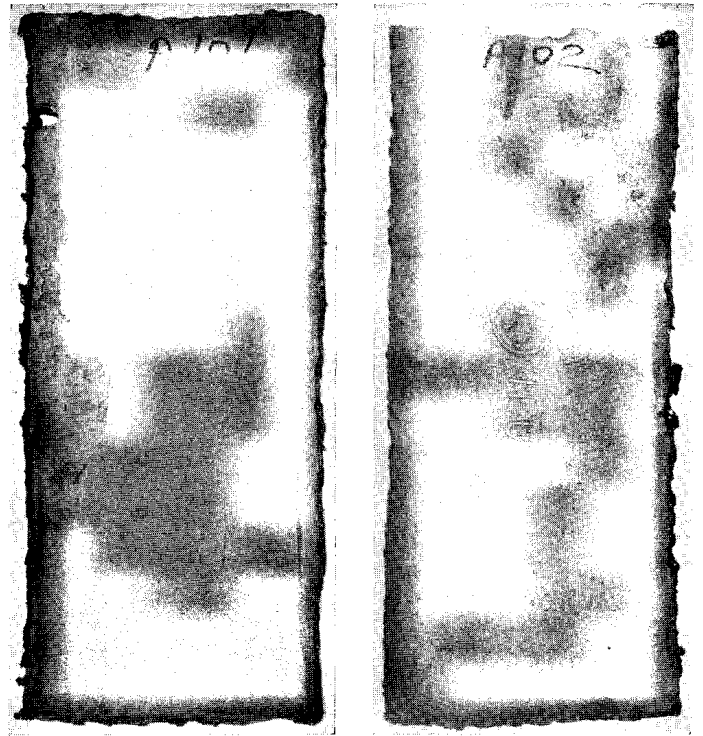
The coal tar coating was intact over the entire surface except at elevation 220.5 to 219.5 ft where the coating was damaged in an area 1-ft in vertical direction by 1-in. in width. The maximum depth of pitting of the steel exposed by the damaged coating was 35 mils (fig. 5). The steel beneath the rest of the coating was unaffected by corrosion and the mill scale was intact.

FIGURE 5. Steel sheet piling sections (2 ft by 1 ft) cut from two locations on the Memphis Floodwall after exposure for 6.3 years.

The sections were cleaned by sandblasting.

A101, section of coated piling showing pits up to 35 mils in depth, occurring in area of damaged coating.

A102, section of uncoated piling exposed to a silty clay containing cinders showing no measureable corrosion.

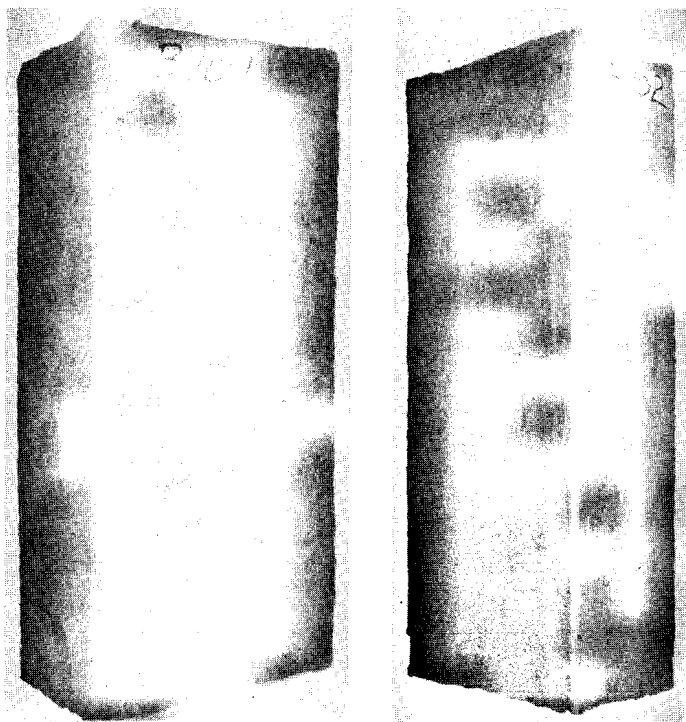
FIGURE 6. Sandblasted sections of Z-type sheet piling cut from two different locations in the Vicksburg Floodwall after exposure for 7 years.

Although cinders were present in the soil at both locations, no significant corrosion occurred.
