Corrosion of Steel Pilings in Soils

Melvin Romanoff

National Bureau of Standards Monograph 58

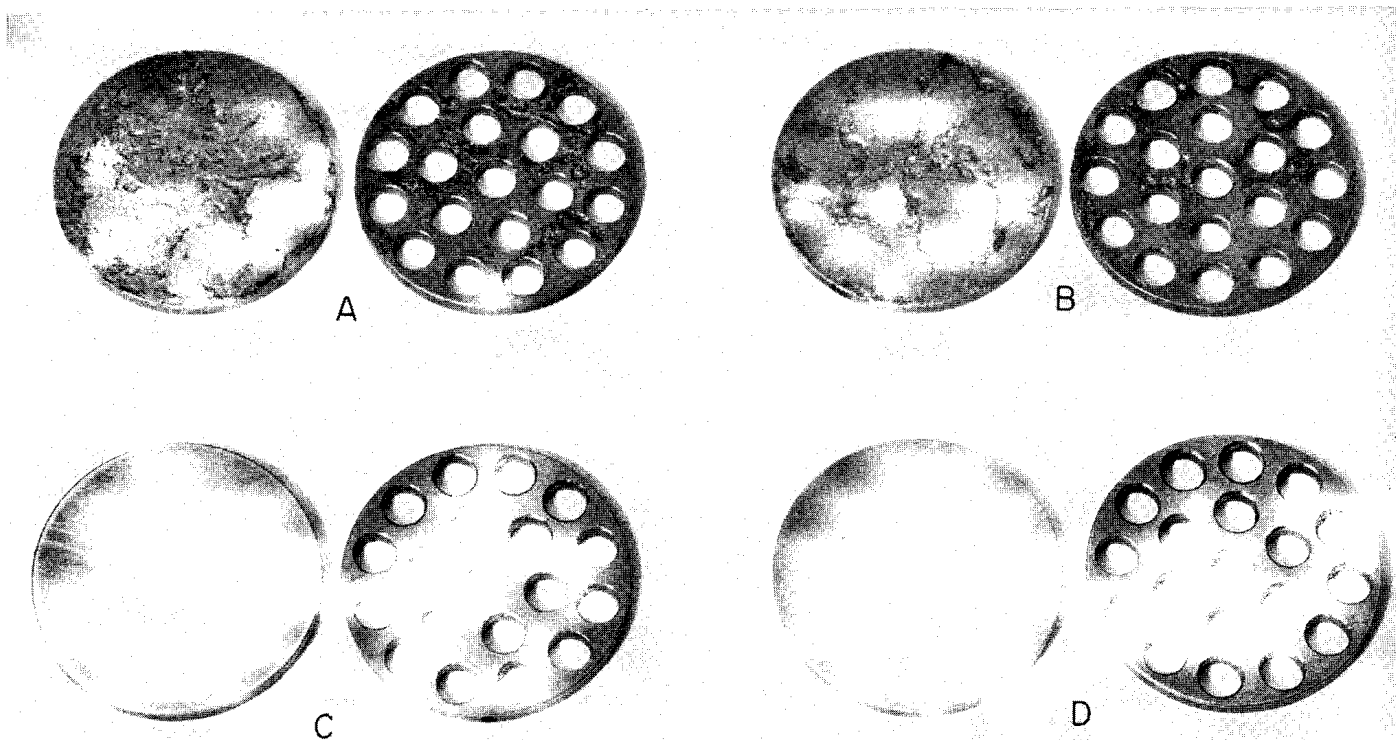
FIGURE 7. Corrosiveness of soil samples from Bonnet Carre Spillway as indicated by electrode weight losses after 6 months in modified Denison corrosion cells.

Electrode sets A and C set up under aerated and unaerated conditions, respectively, with soil samples obtained at 22 ft depth from surface of ground. Electrode sets B and D set up under aerated and unaerated conditions, respectively, with soil samples obtained at 45 ft depth.

It was previously pointed out that the soil samples from the piling which was extracted from the Bonnet Carre Spillway had properties similar to those of the severely corrosive Docas clay soil in the NBS field tests. The laboratory corrosion cell set up under the aerated conditions produced weight losses of the same order of magnitude for the Bonnet Carre (fig. 7, A and B) and Docas clay soils [1,16] indicating that the Bonnet Carre soil is equally as corrosive as the Docas clay soil under aerated conditions. The weight losses of ferrous pipe specimens which were exposed in the disturbed soil at the Docas clay site are in relatively good agreement with the results obtained in the laboratory under aerated conditions.

The importance of oxygen as a factor in the corrosion process was previously indicated, by the behavior of steel in the modified Denison corrosion cell set up under aerated and unaerated conditions in the laboratory on soil samples from the Bonnet Carre Spillway (fig. 7).
